BEAVER POND DAM

**NDI No. PA 00133
PennDER No. 64-19
Dam Owner: Marguerite Card**

**PHASE I INSPECTION REPORT
NATIONAL DAM INSPECTION PROGRAM**

Beaver Pond Dam, Wayne County, Pennsylvania
NDI No. PA 00133, PennDER No. 64-19
Unnamed Tributary of Shadigee Creek
Inspected 28 October 1980

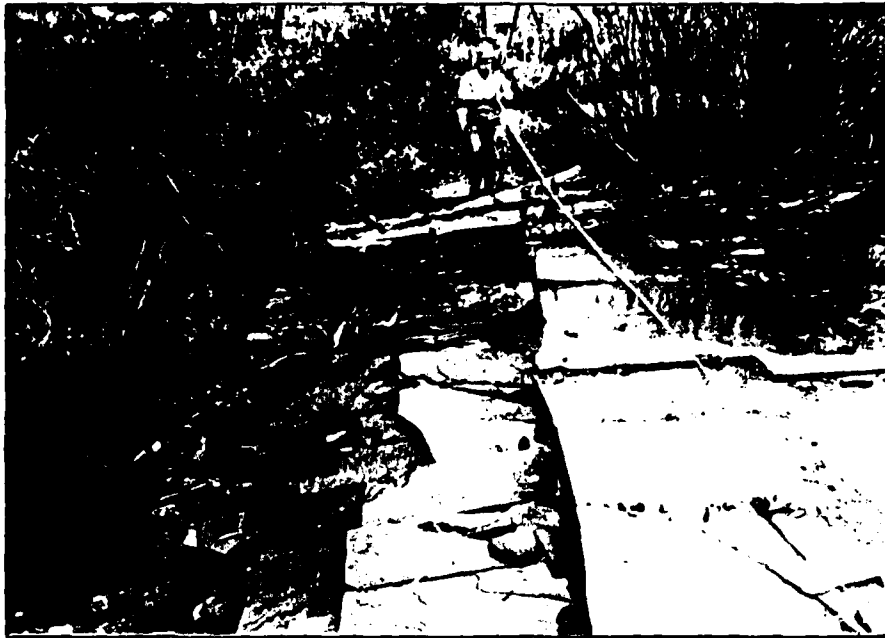
PHOTO 3. View Across Dam Towards Right Abutment

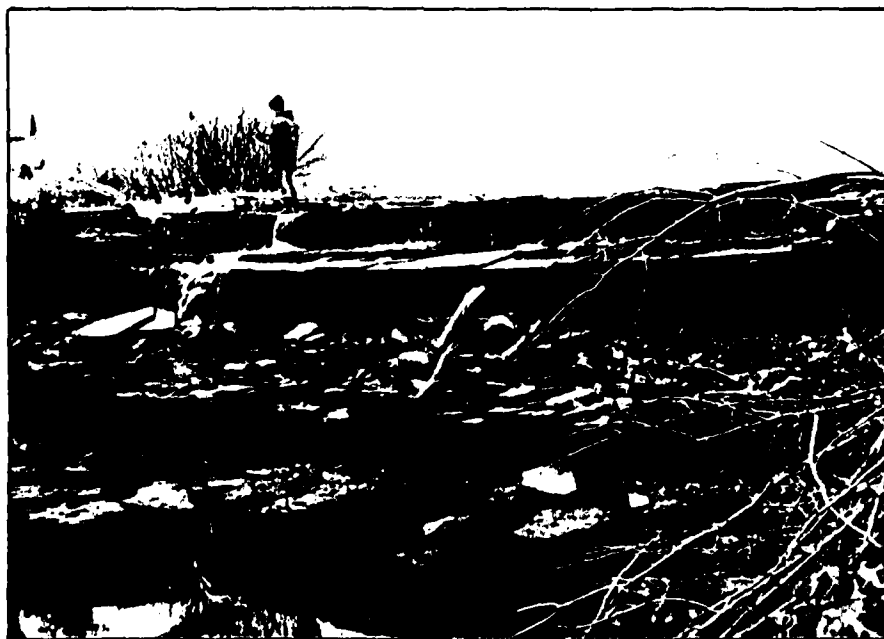
- c. Appurtenant Structures - The spillway consists of pieces of slate laid horizontally to form a cap. There was debris and brush partially blocking the right side of the spillway.

PHOTO 6. Downstream View of Spillway

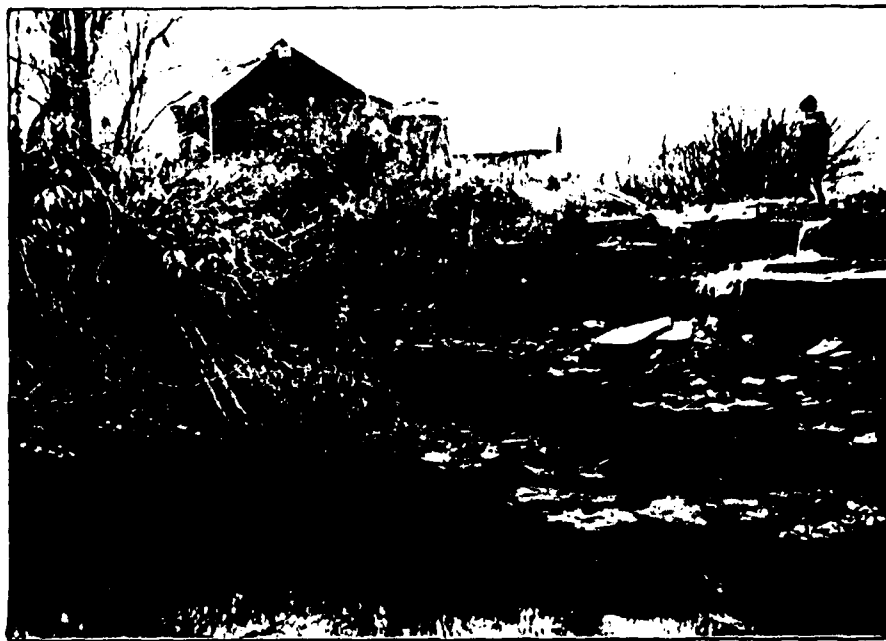
PHOTO 7. Downstream View of Right Half of Dam
